WL-TR-95-4108

**HIGH TEMPERATURES COATINGS
FOR TITANIUM ALUMINIDES**

**J. C. Schaeffer
R. L. McCarron**

**GENERAL ELECTRIC COMPANY - AIRCRAFT ENGINES
ENGINEERING MATERIALS TECHNOLOGY LABORATORIES
CINCINNATI, OHIO 45215-6301**

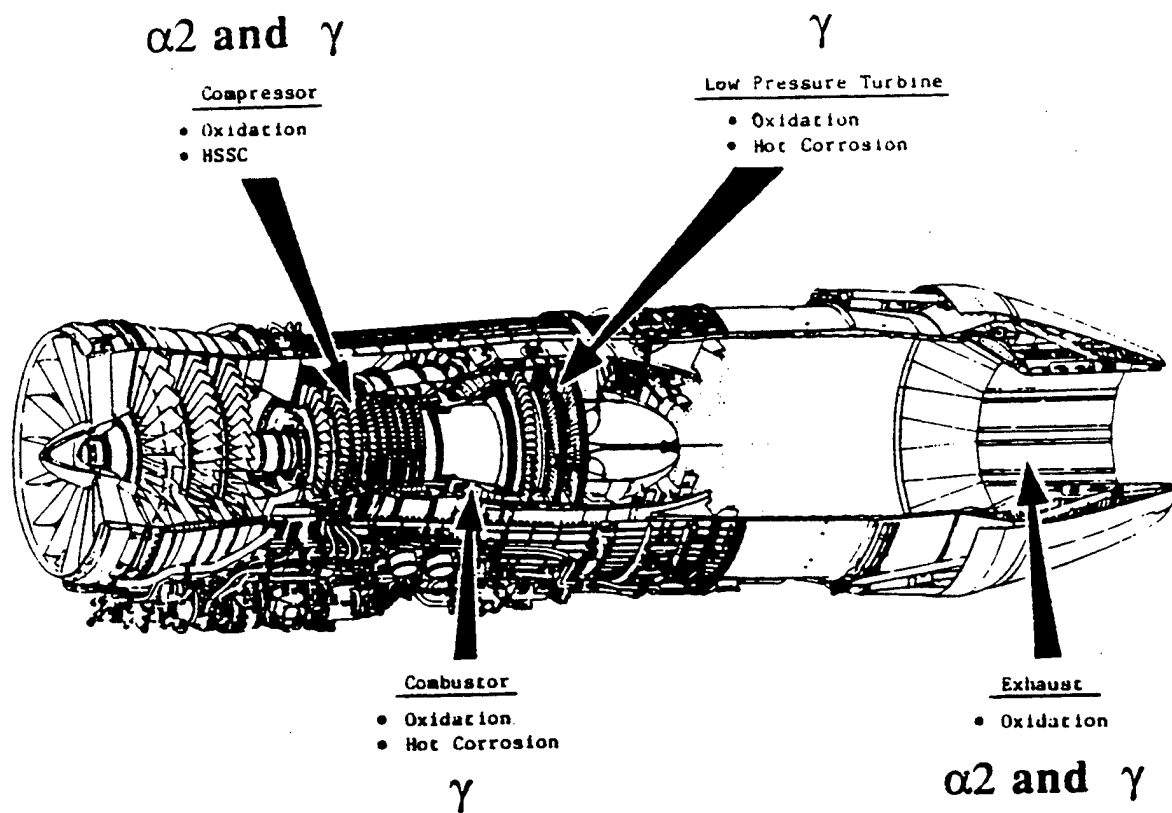
Figure 1. Schematic of gas turbine engine showing the associated types of environmental attack for potential applications of alpha-2 and gamma alloys.

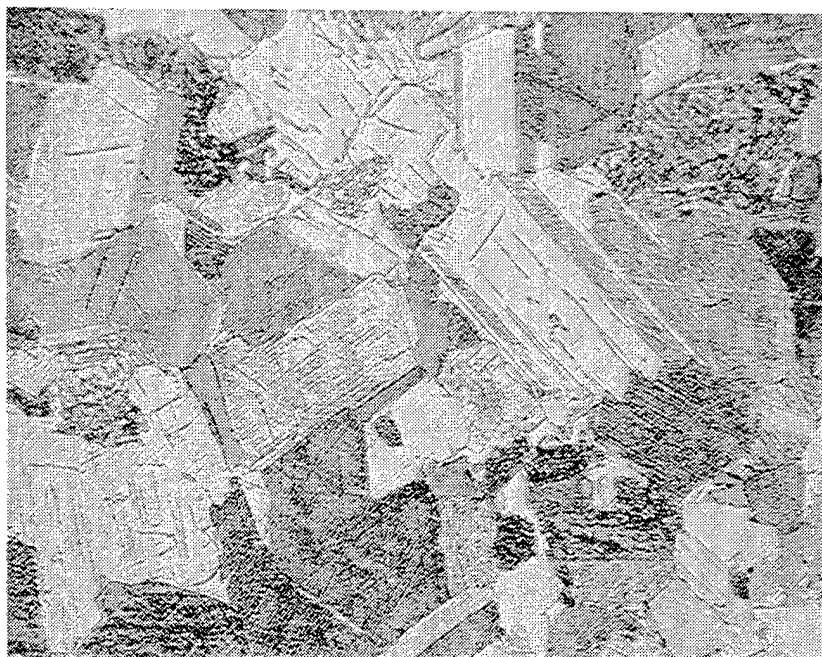
Figure 7. Optical micrographs showing Ti-48Al-2Cr-2Nb after forging, heat treating and machining. The samples are etched in a solution of 2%HF and methanol.

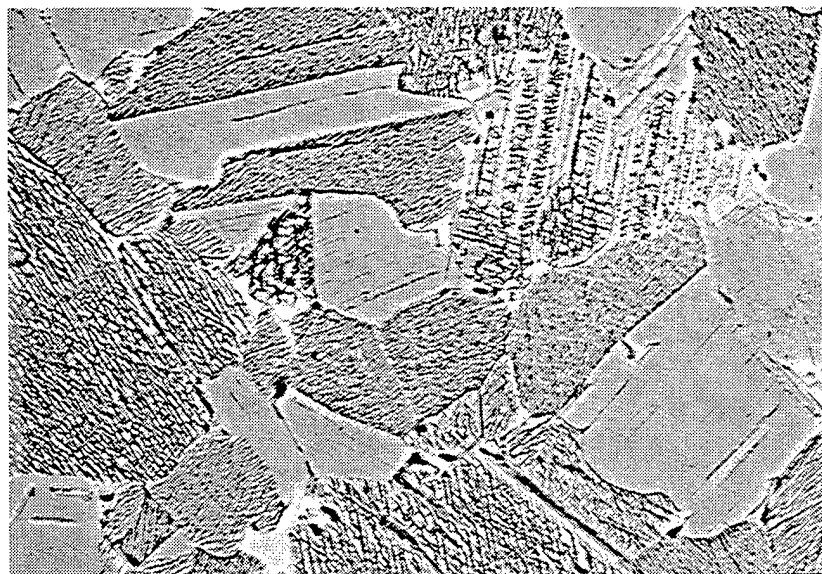
Figure 8. Backscattered electron images (BEI) showing Ti-48Al-2Cr-2Nb after pancake forging and heat treatment. The microstructure is duplex and composed of primary gamma grains and transformed alpha.

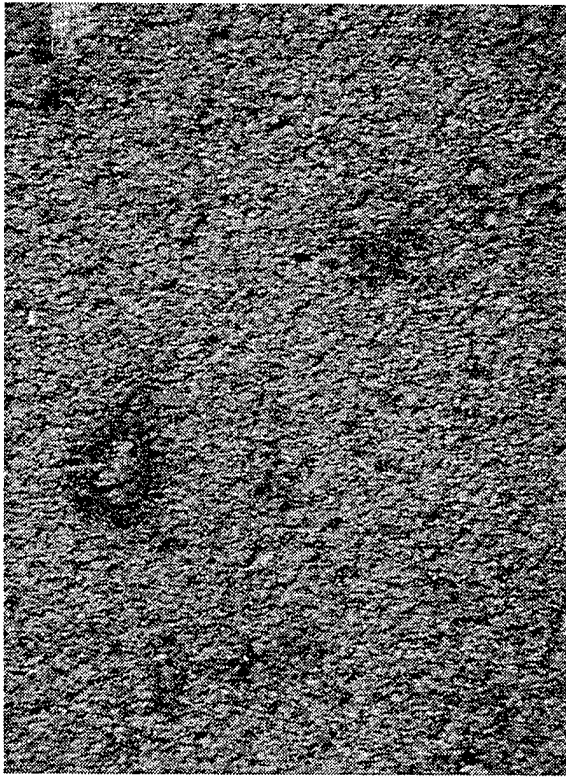
100 Cycles

Figure 16. Low magnification optical micrographs showing the surface of the LPPS Ti-44Al-28Cr coating on Ti-48Al-2Cr-2Nb after 100,300 and 500Hr. of cyclic oxidation in air at 900°C (1652°F).

Unacceptable behavior was exhibited by the gamma alloys coated with plasma sprayed Ti-44Al-28Cr. These samples had nodular growths of titania on the surfaces as seen in Figures 16 and 17.

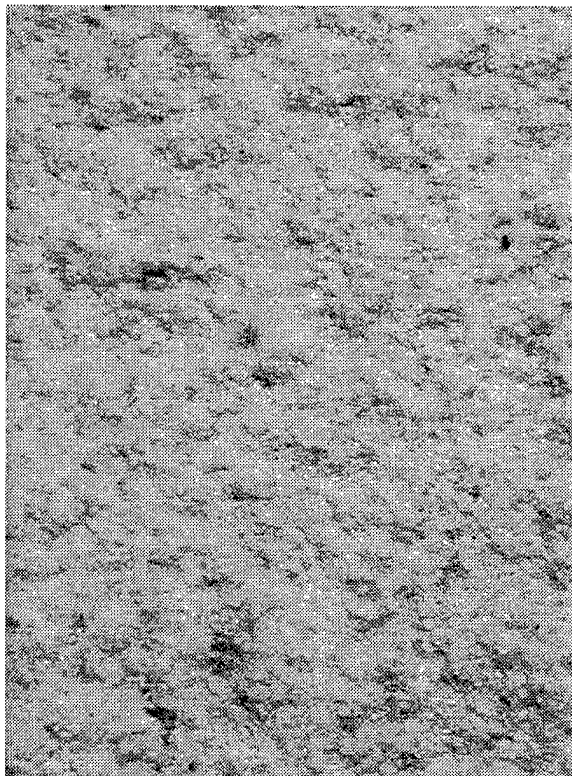
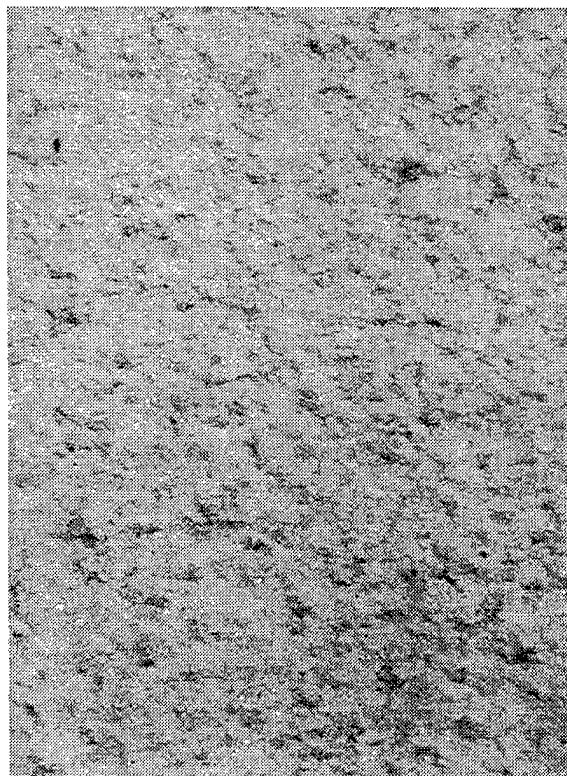
Figure 19. Low magnification optical micrographs showing the surface of the APS YSZ coating on the Ti-47Al-2Cr-4Ta after 100, 300 and 500Hr. of cyclic oxidation in air at 900°C (1652°F).

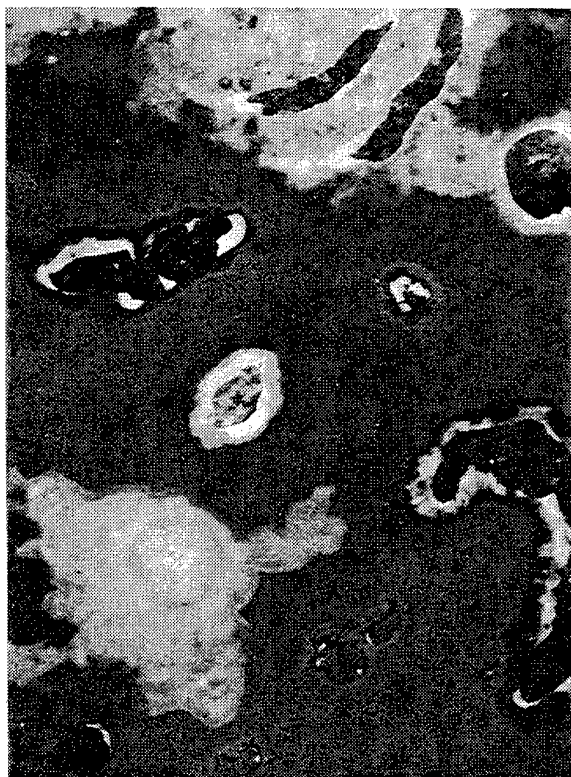
100 Cycles

Figure 22. Low magnification optical micrographs showing the surface of the M³ coating (NiCrAlY and Al₂O₃) on the Ti-48Al-2Cr-2Nb after 100, 300 and 500Hr. of cyclic oxidation in air at 900°C (1652°F).

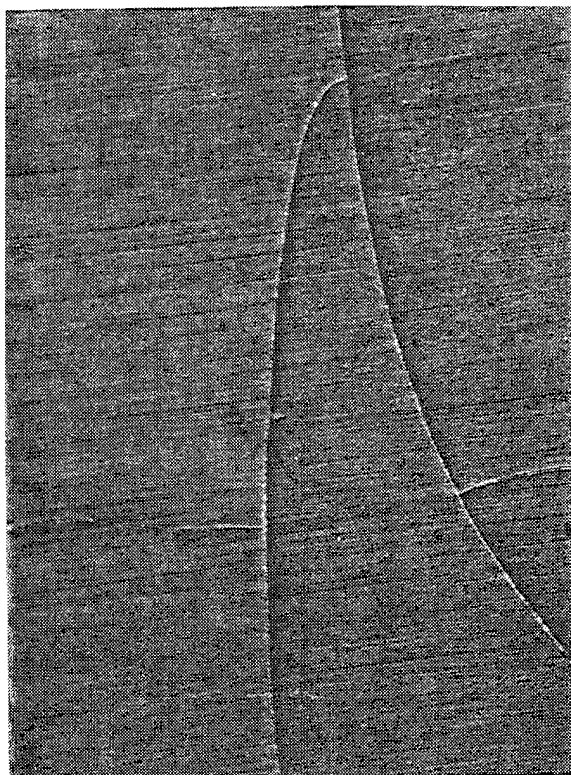
100 Cycles

Figure 24. Low magnification optical micrographs showing the surface of the sputtered Ti-44Al-28Cr on Ti-24.5Al-12.5Nb-1.5Mo after 100, 300 and 500Hr. of cyclic oxidation in air at 900°C (1652°F).

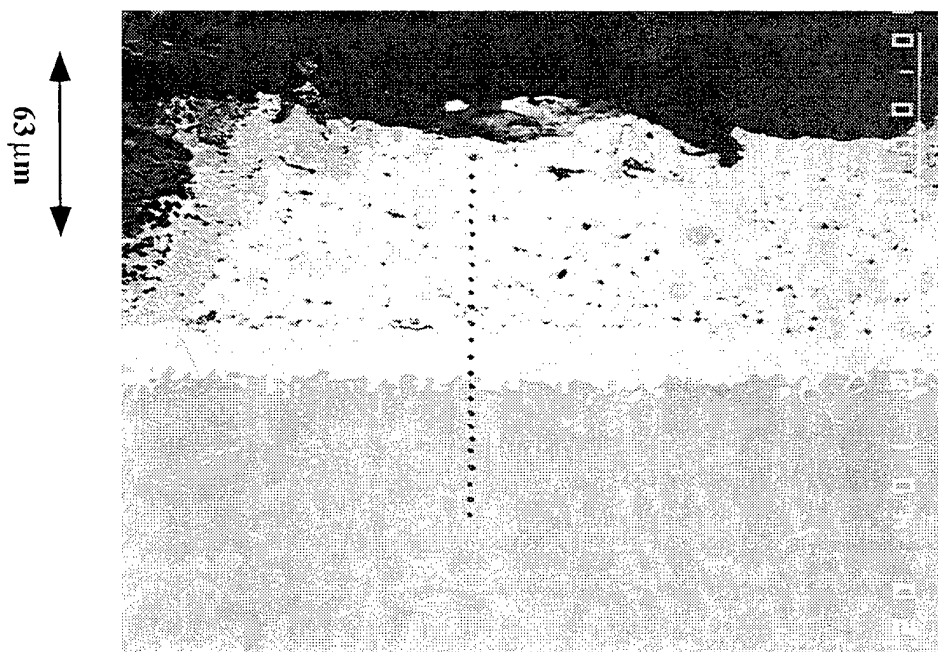
Figure 42. Electron micrographs of the LPPS Ti-44Al-28Cr coating applied to Ti-48Al-2Cr-2Nb. The initial microstructure (top) displays a typical plasma spray appearance. Copper and Ni-base superalloy contamination were noted in the sample (arrow). The exposed microstructure (bottom) shows areas where a protective alumina scale has formed and areas where non-protective rutile dominates.

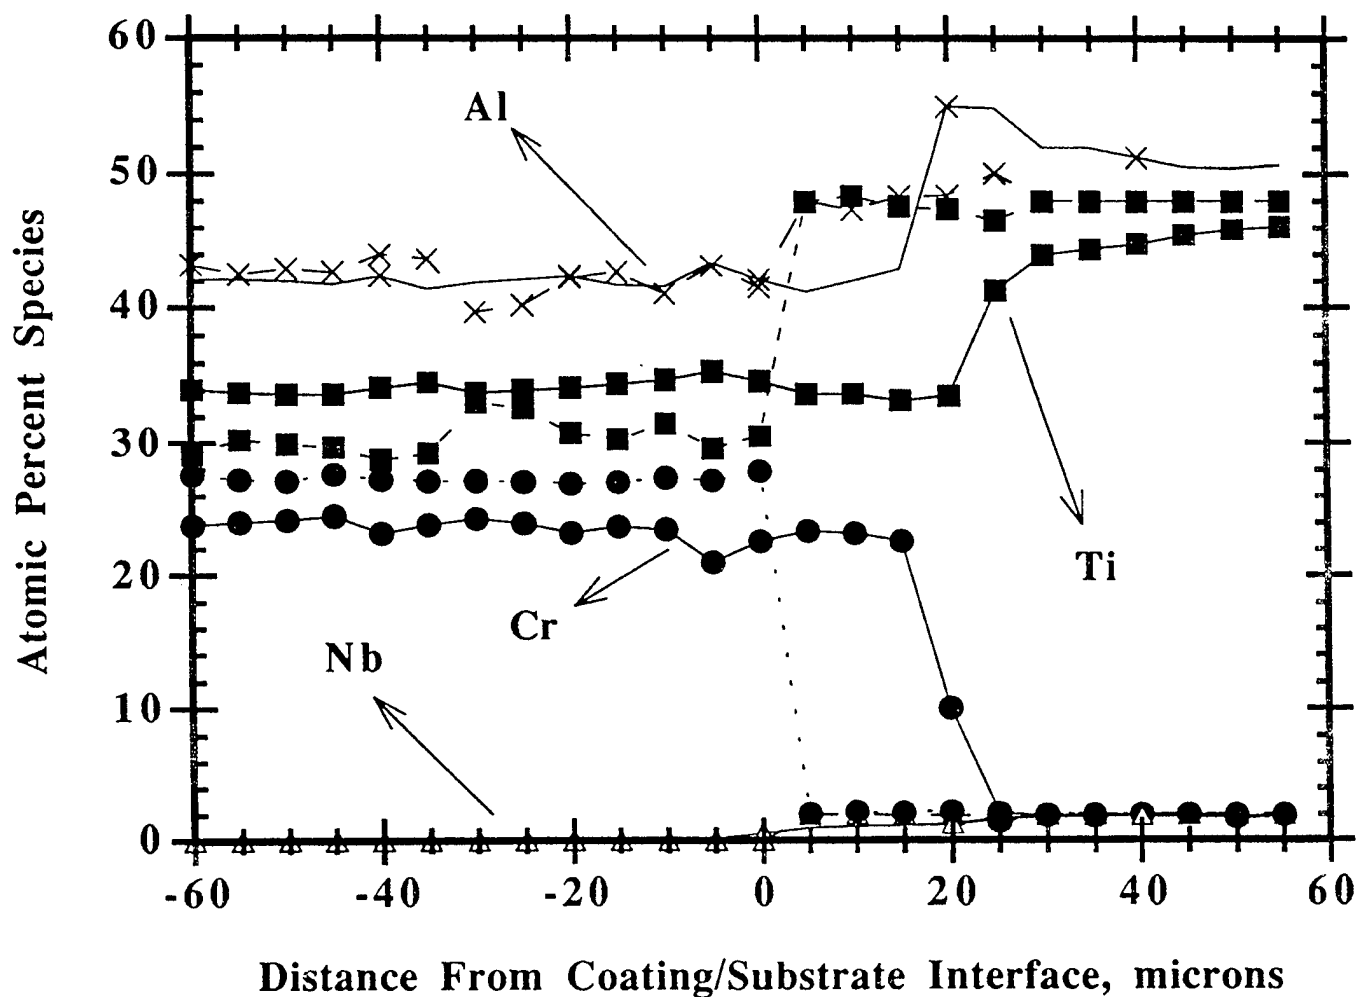
Figure 43. Microprobe traces for the elements in the LPPS Ti-44Al-28Cr coating on Ti-48Al-2Cr-2Nb. The dotted lines represents the initial chemistry while the solid lines are after the 500Hr. exposure at 900°C (1650°F).

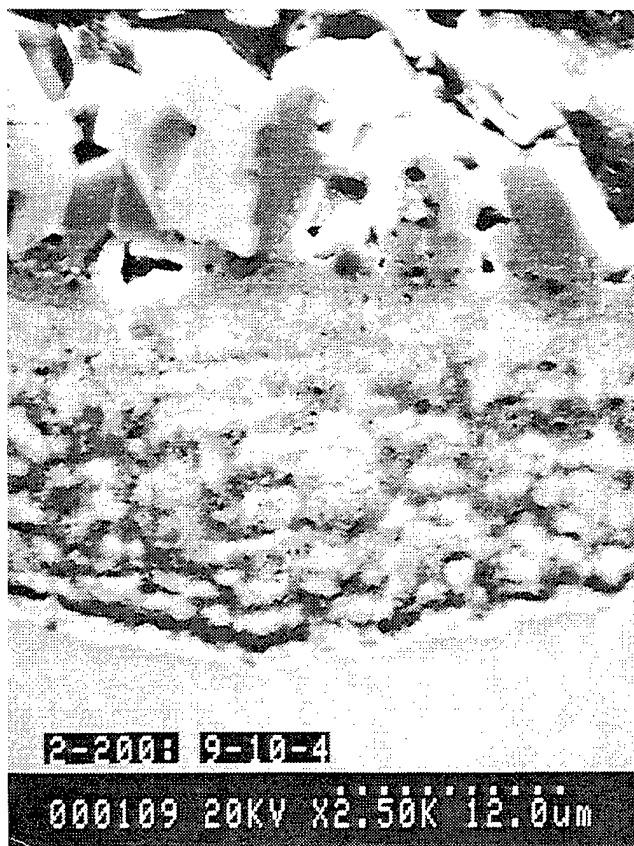
Figure 45. Secondary electron micrographs of the oxide scale formed on Ti-48Al-2Cr-2Nb. The oxide had locally thick areas that were associated with spallation.

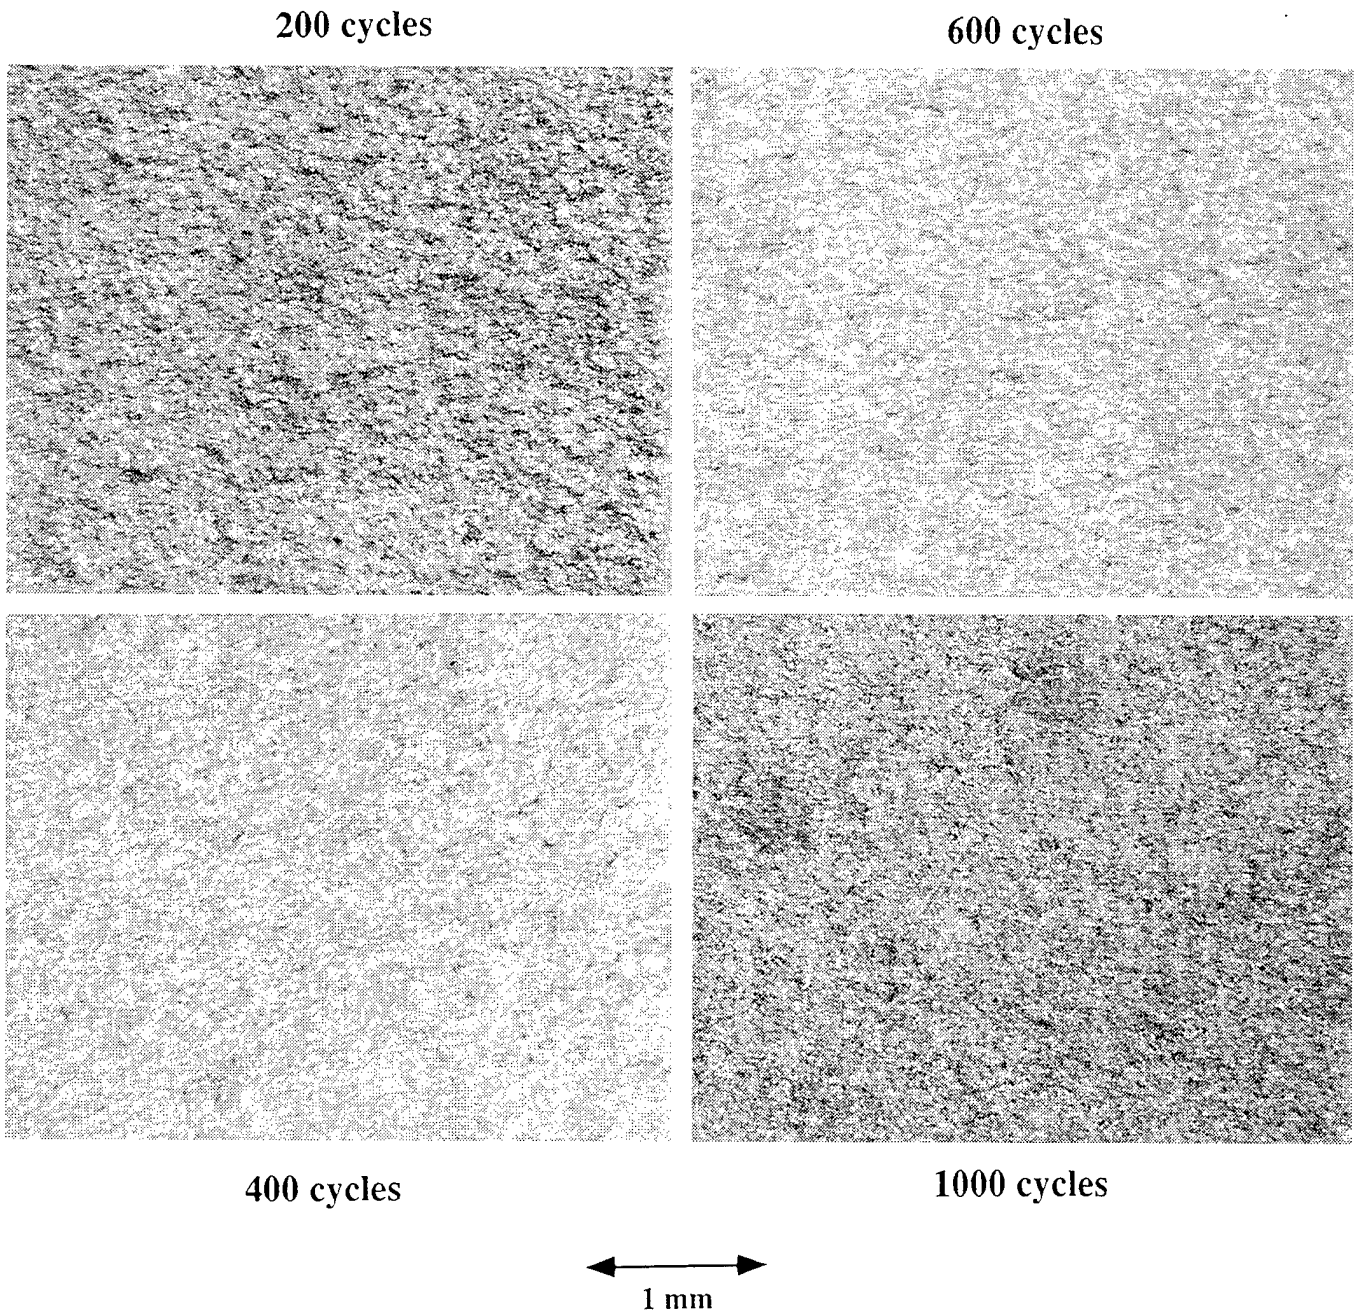
Figure 46. Surface optical micrographs of the cermet (80%Alumina + NiCrAlY) coated gamma sample at various intervals throughout the 760°C (1400°F) cyclic oxidation test in air.

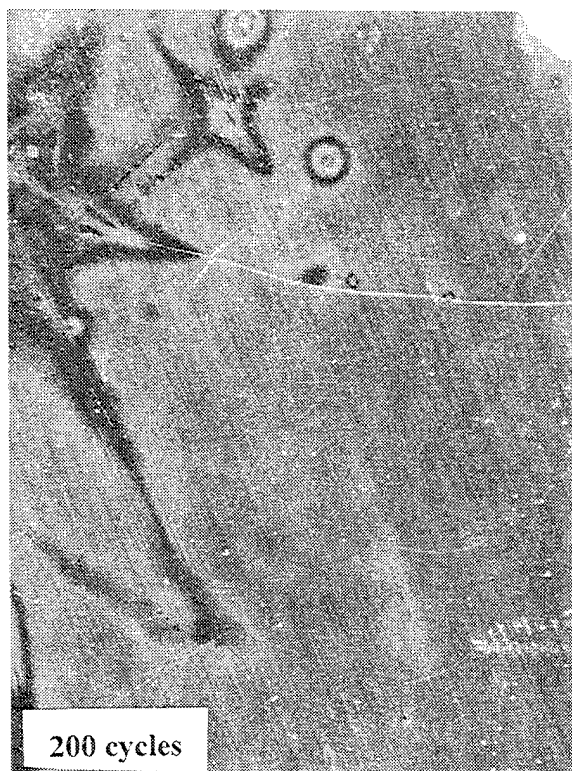
Figure 49. Surface optical micrographs of the sputtered Ti-44Al-28Cr gamma sample at various intervals throughout the 760°C (1400°F) cyclic oxidation test in air. Some thermal expansion mismatch cracks are observed.

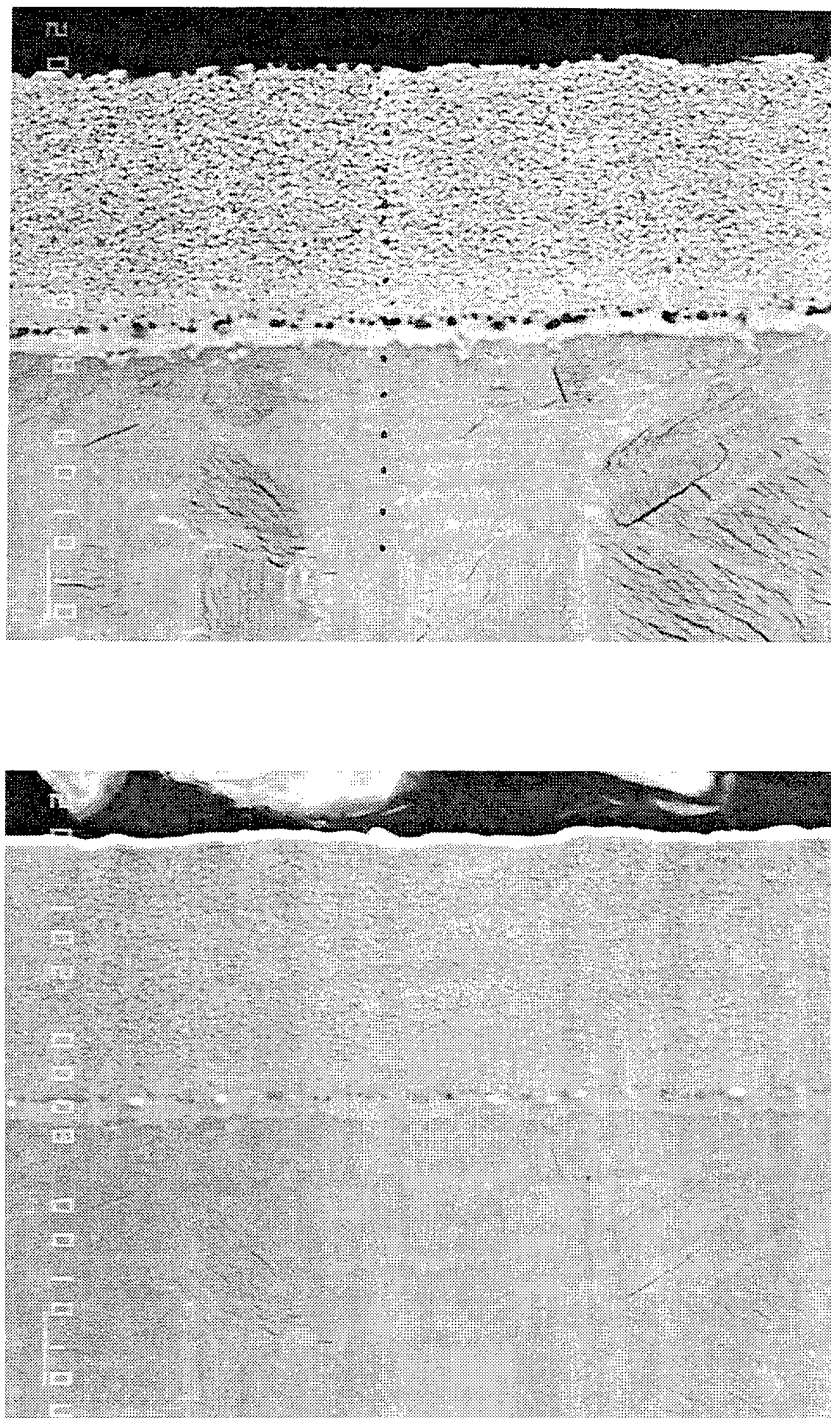
Figure 50. Backscattered and secondary electron micrographs from a cross section of the sputtered Ti-44Al-28Cr gamma sample after the 760°C (1400°F) cyclic oxidation test in air.

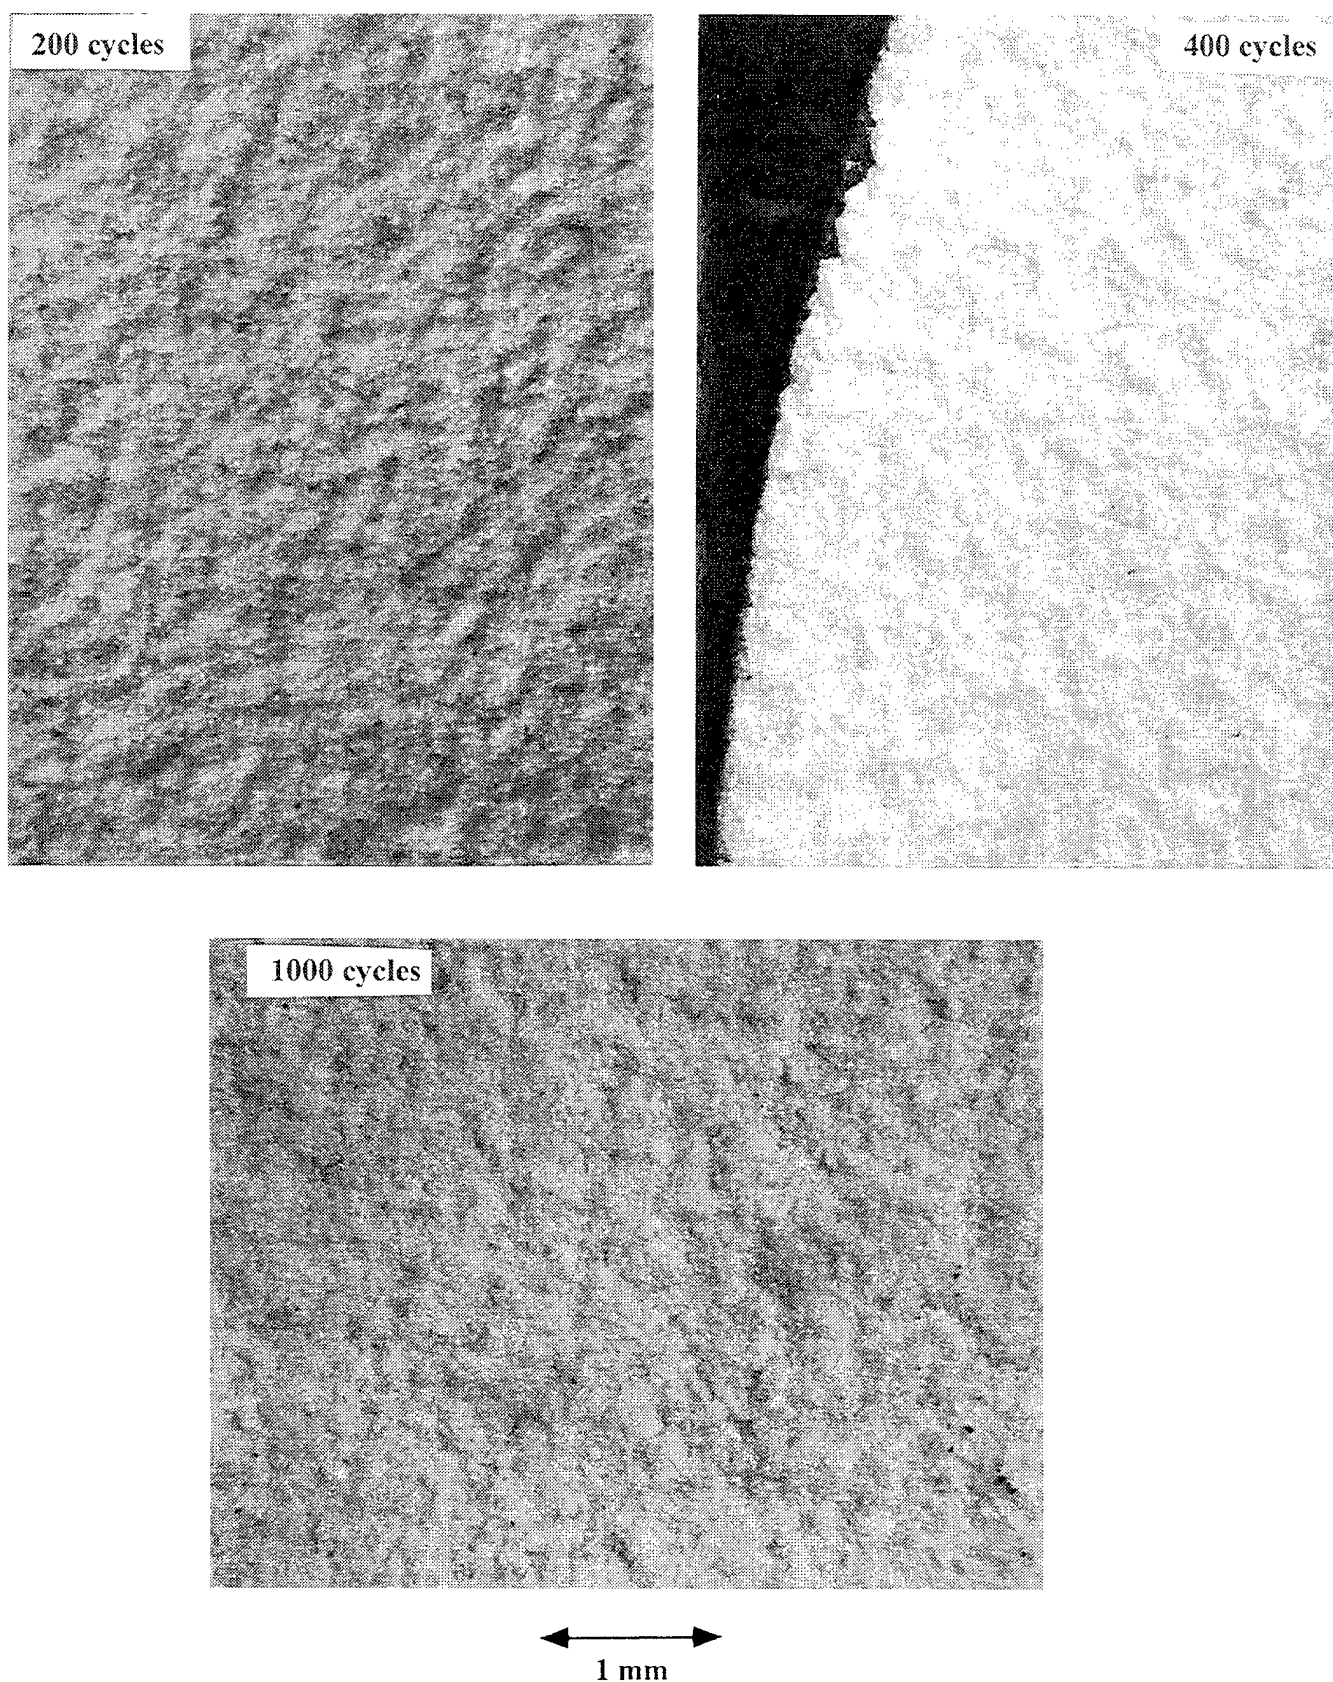
Figure 52. Surface optical micrographs of the APS YSZ gamma sample at various intervals throughout the 760°C (1400°F) cyclic oxidation test in air. Coating spallation was evident at the edges.

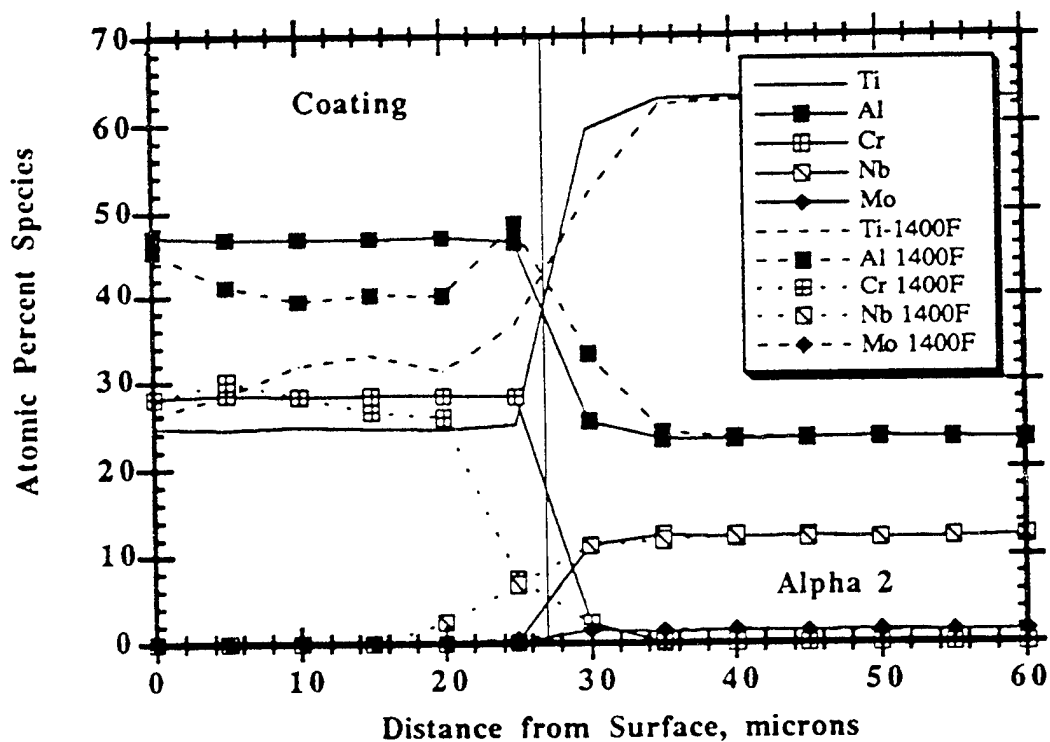
Figure 64. Microprobe traces for the elements that compose the sputtered Ti-44Al-28Cr coating on Ti-24.5Al-12.5Nb-1.5Mo.

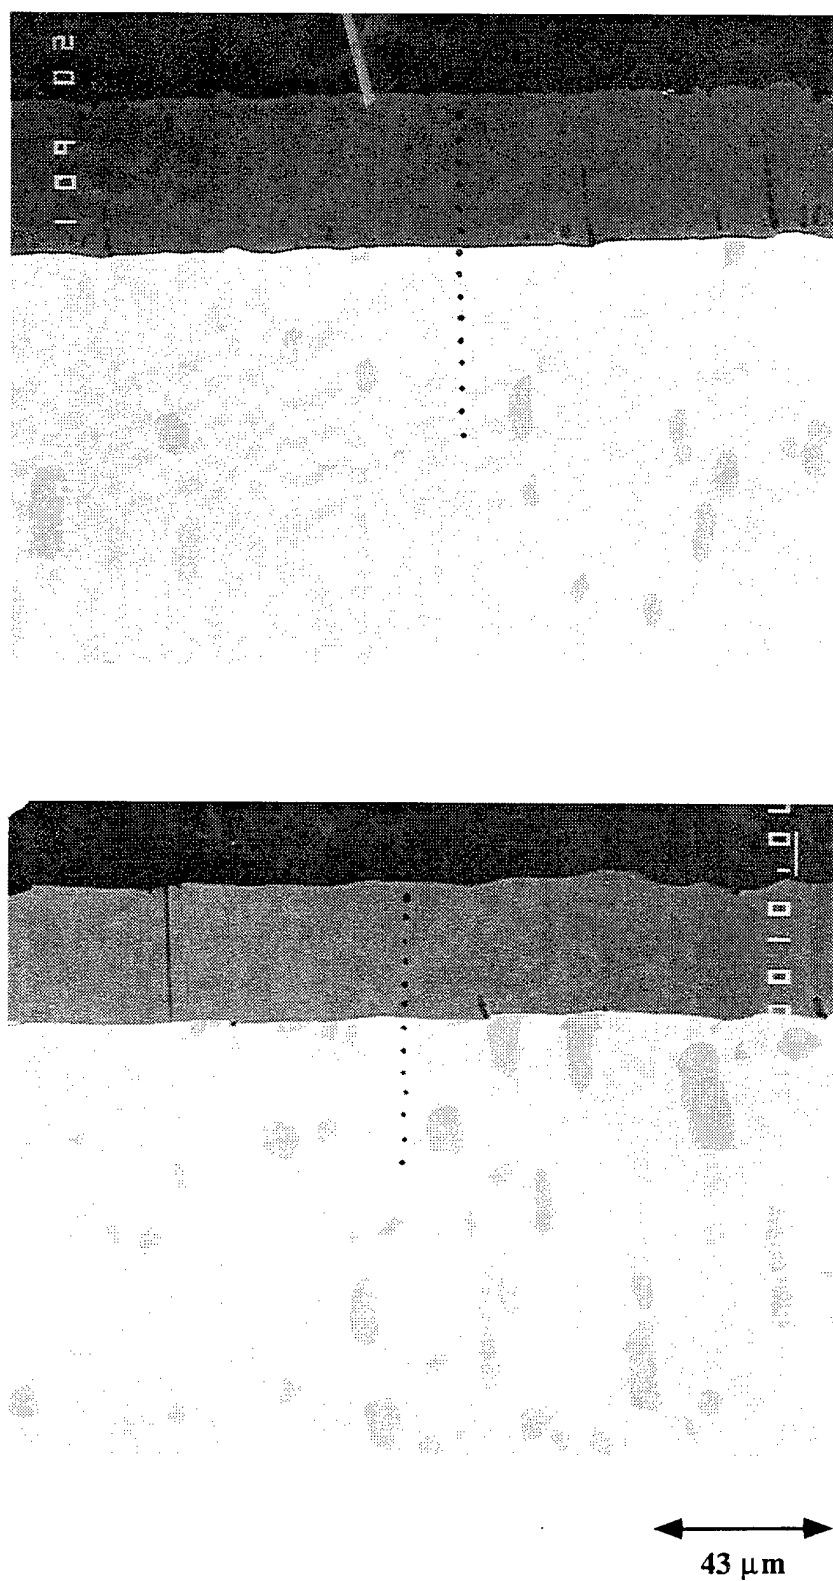
Figure 65. Backscattered electron micrographs of the sputtered Ti-55Al-8.5Cr on Ti-24.5Al-12.5Nb-1.5Mo. Some through thickness defects are noted in the coating.

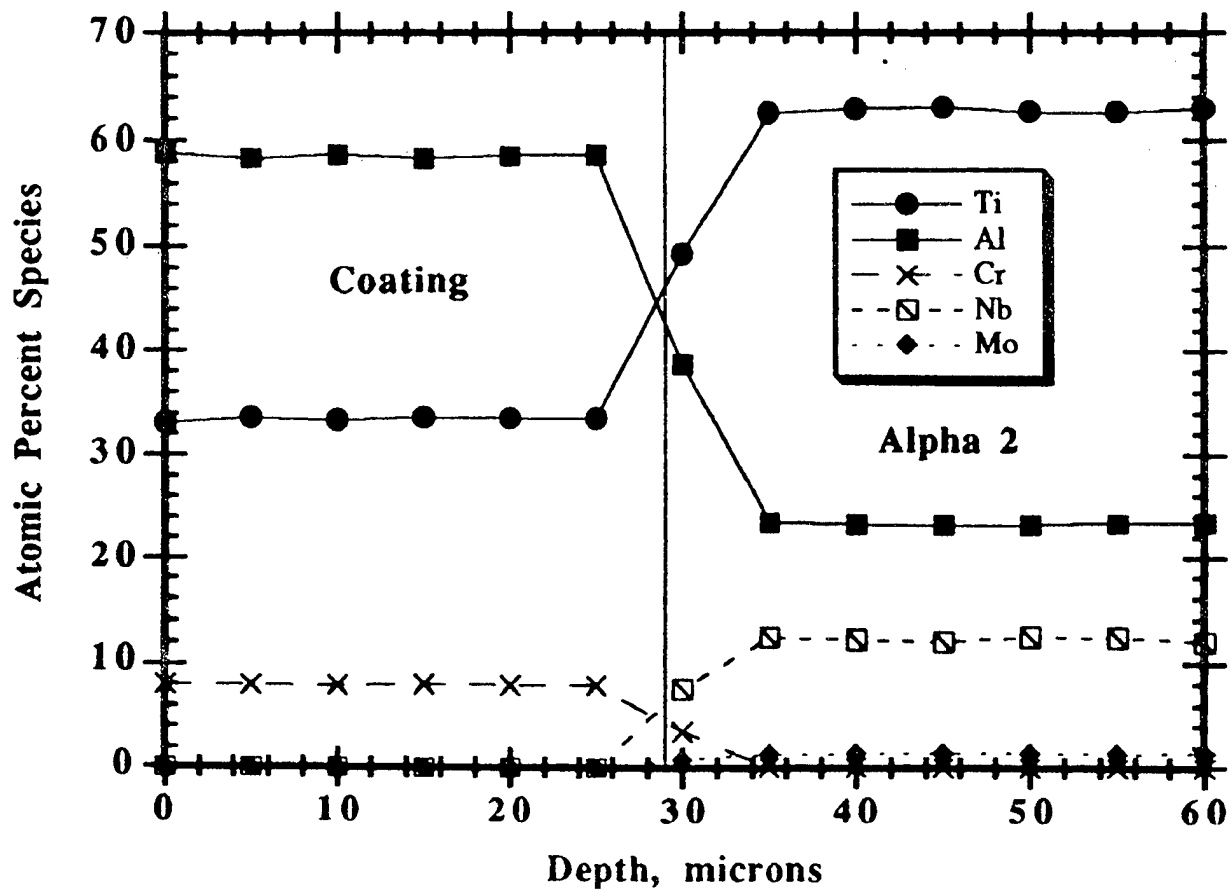
Figure 66. Microprobe traces for the elements that compose the sputtered Ti-55Al-8.5Cr coating on Ti-24.5Al-12.5Nb-1.5Mo.

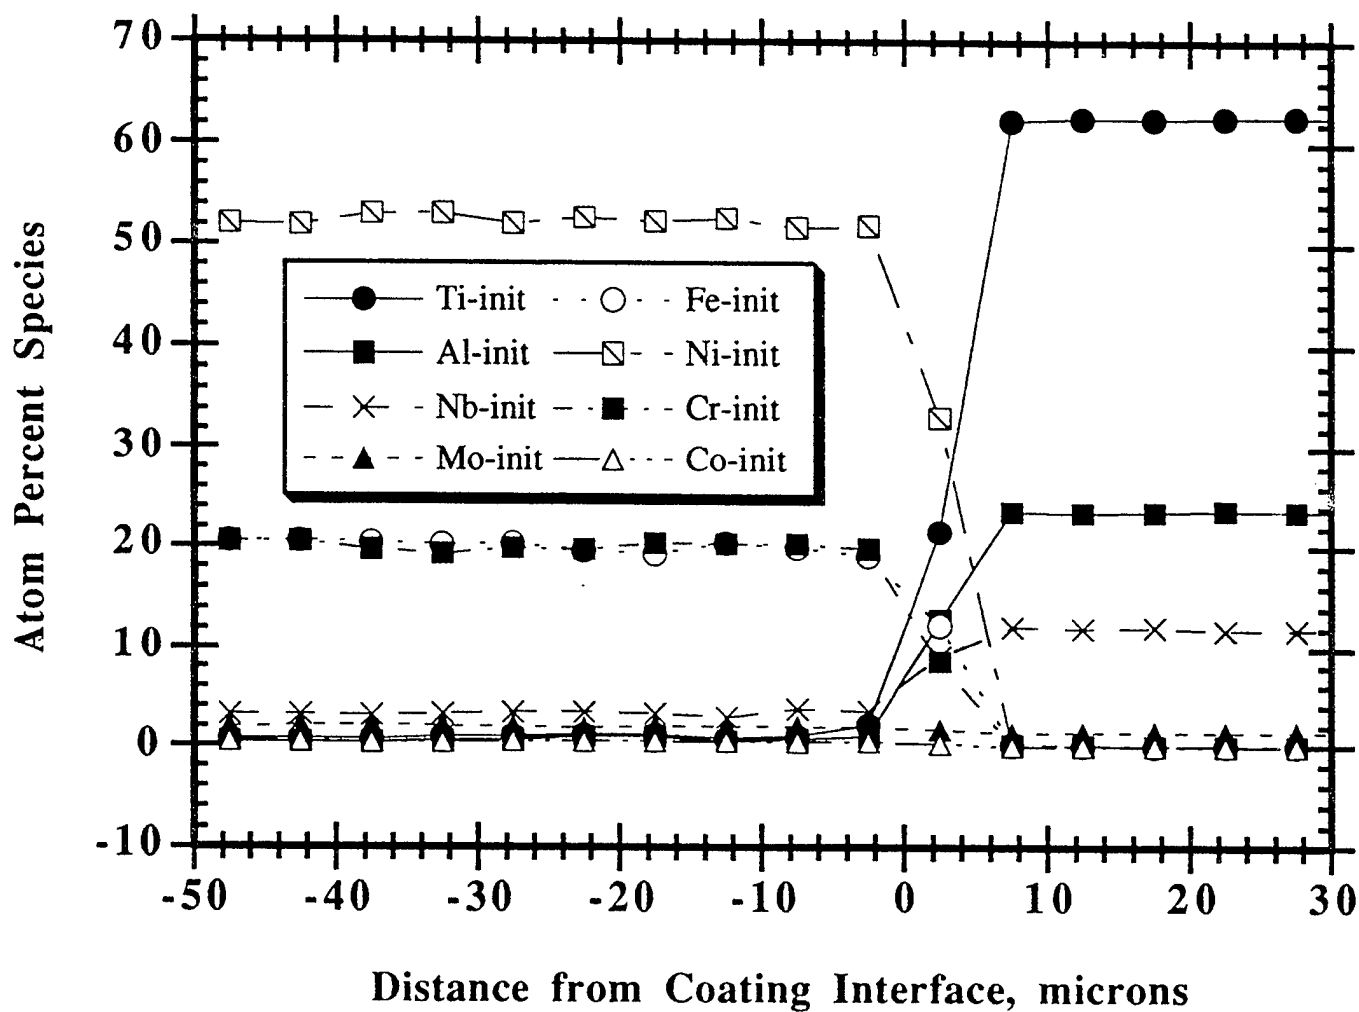
Figure 71. Microprobe traces for the elements that compose the APS 718 coating on Ti-24.5Al-12.5Nb-1.5Mo.

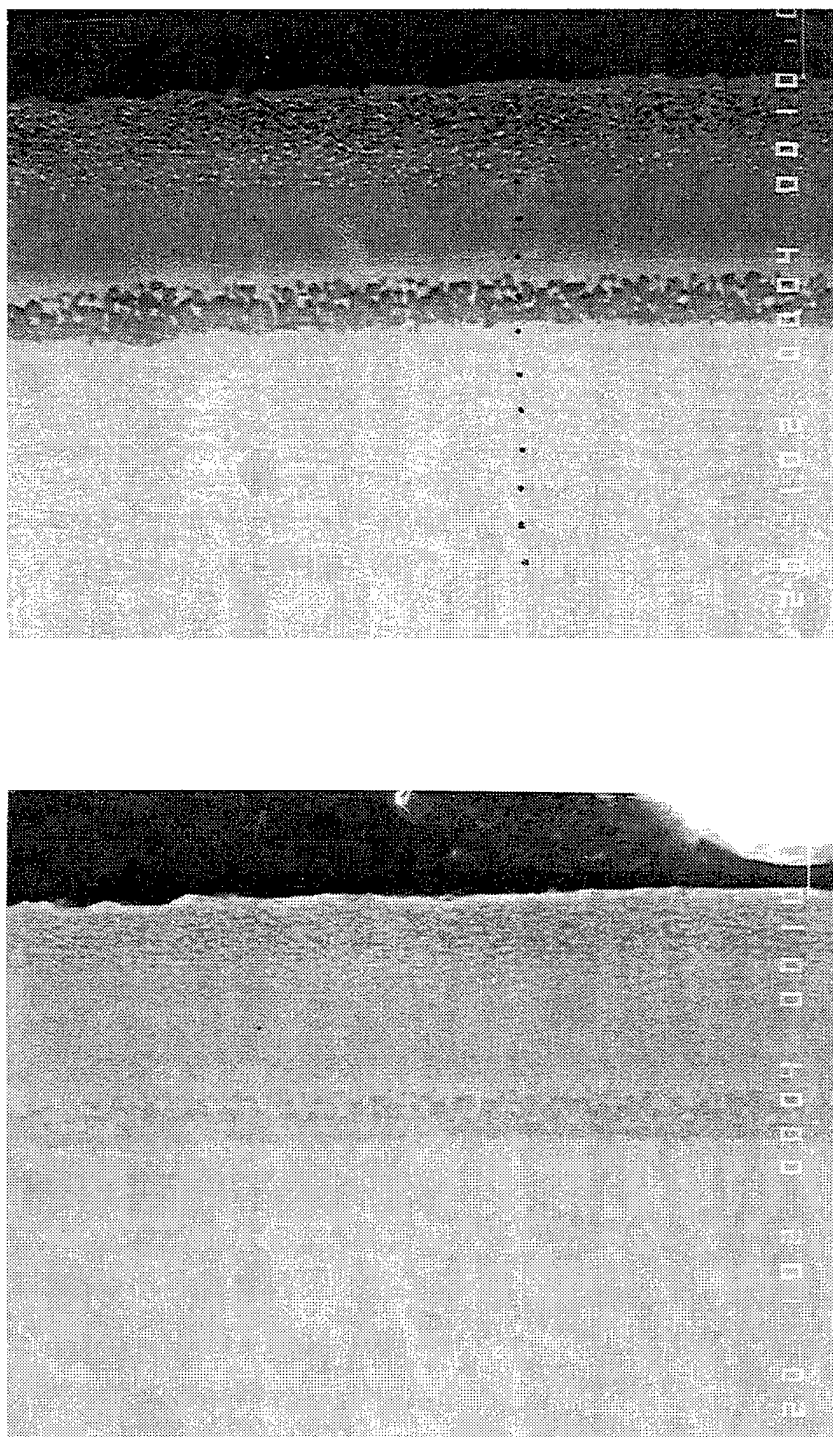
Figure 74. Backscattered and secondary electron micrographs from a cross section of the sputtered Ti-44Al-28Cr alpha-2 sample after the 760°C (1400°F) cyclic oxidation test in air.

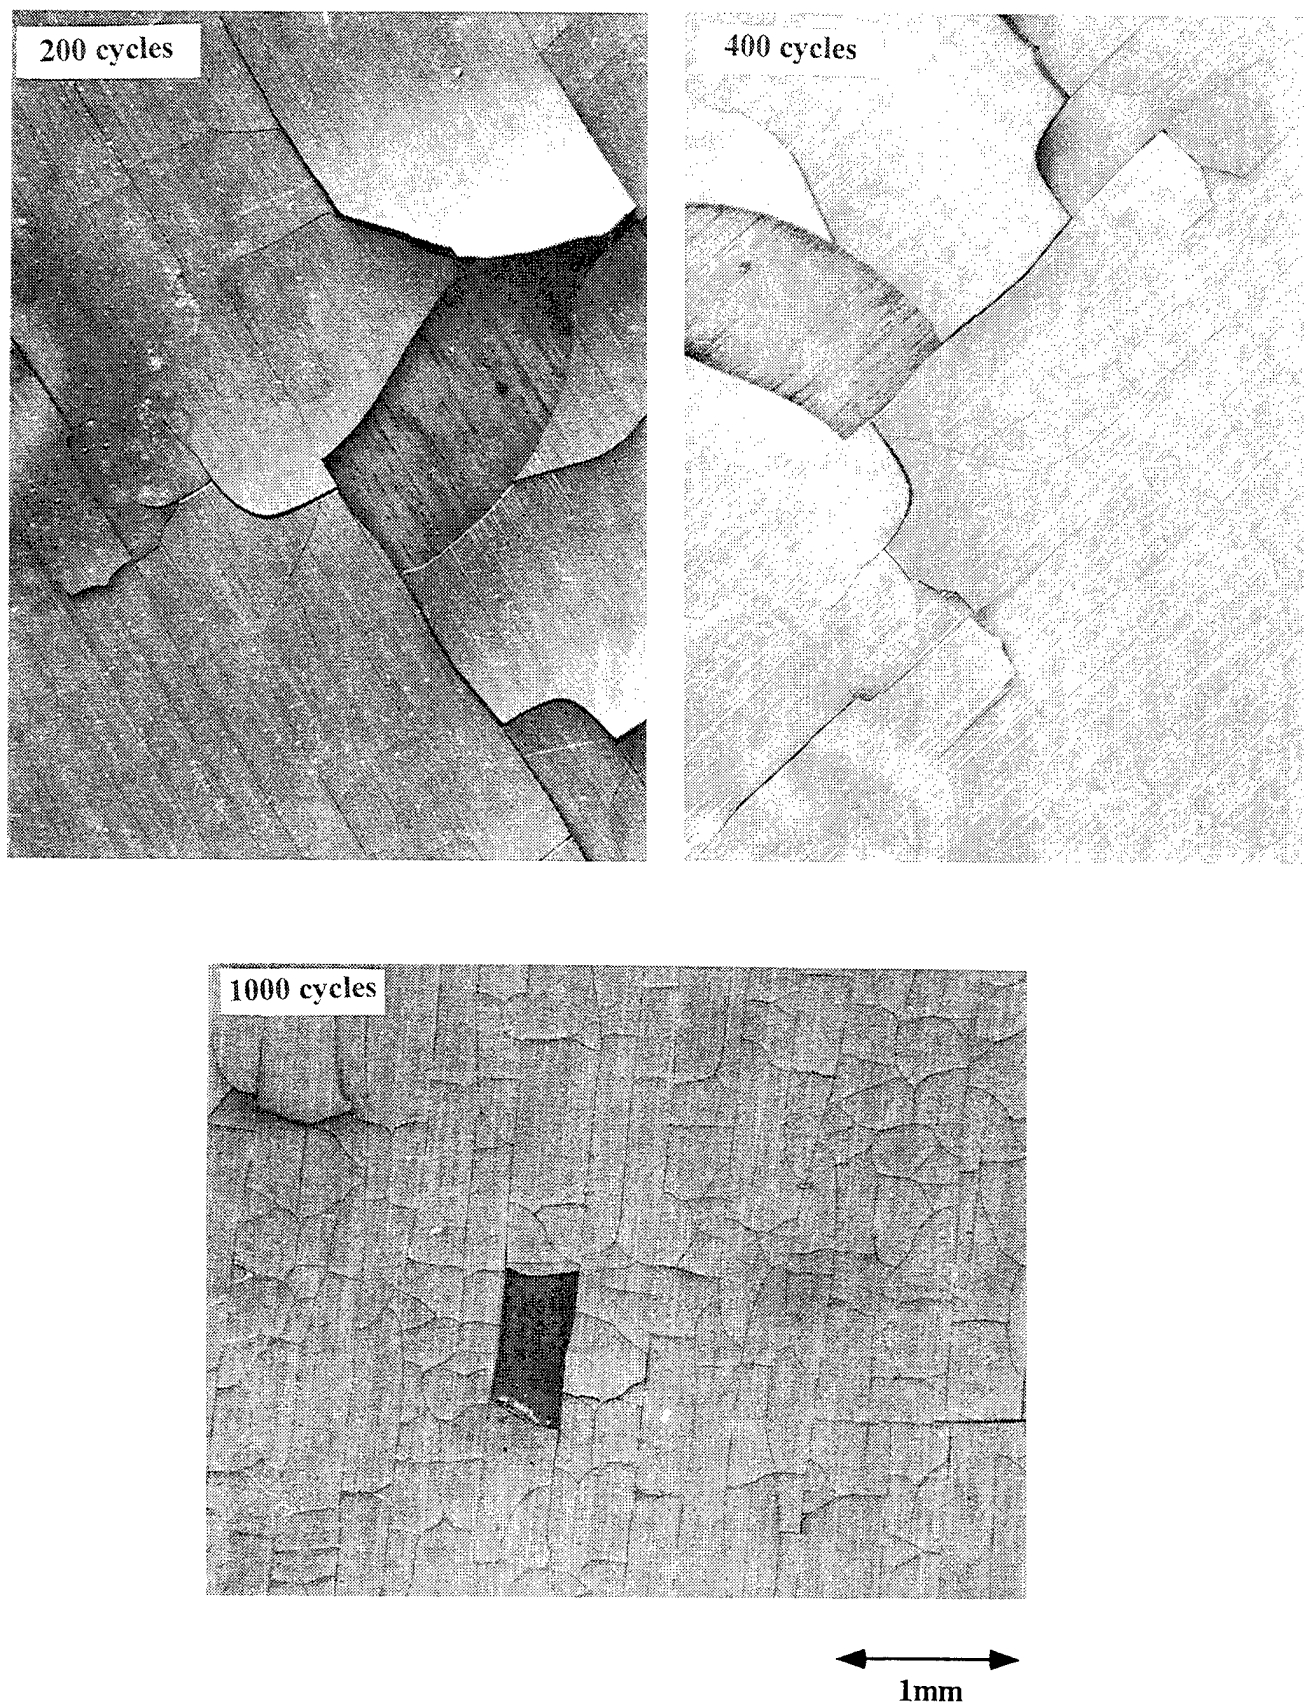
Figure 79. Surface optical micrographs of the sputtered Ti-55Al-9Cr gamma sample at various intervals throughout the 760°C (1400°F) cyclic oxidation test in air. Large thermal expansion mismatch cracks are observed along with coating spallation.

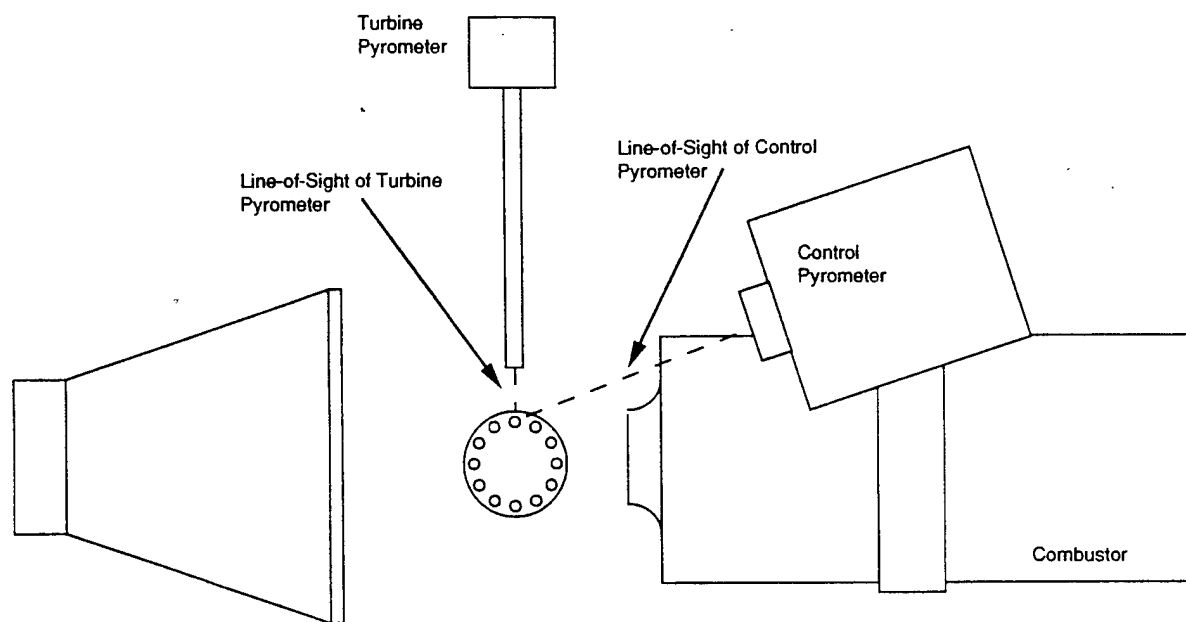
Figure 85. A schematic of the high velocity hot corrosion/oxidation rig used to test coated and uncoated Ti-aluminides in engine simulative environments. Photograph of the CHC/O rig in operation. The samples rotate on a carousel in front of a combustor.

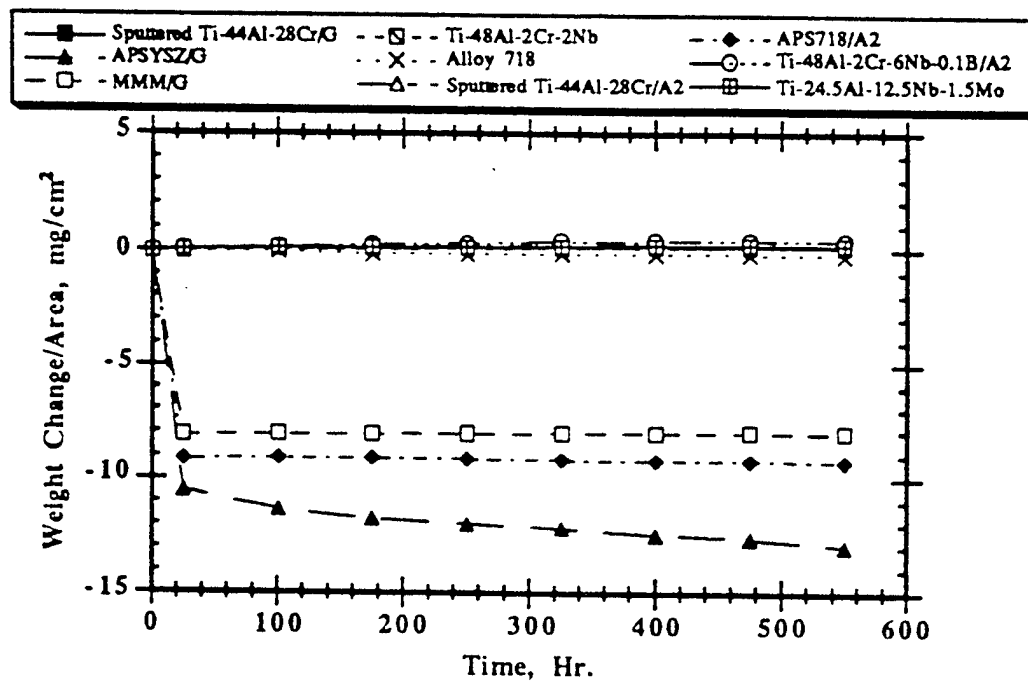
Figure 87. Weight change/area data for unrinsed coated and uncoated Ti-aluminides during the high pressure compressor burner rig test. Thermally sprayed coatings had large spallation events early in the test. The other coatings exhibited little weight change.
